**Lloyd Shoals Relicensing
Study Results Meeting - July 29, 2020
Agenda**

Lloyd Shoals Project (FERC No. 2336)

Study Results Meeting
Lloyd Shoals Project
July 29, 2020

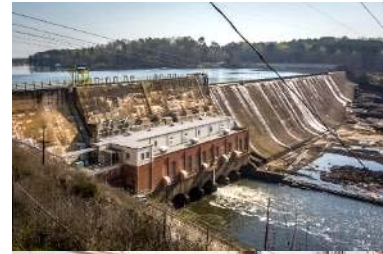
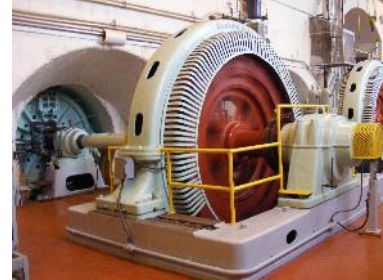
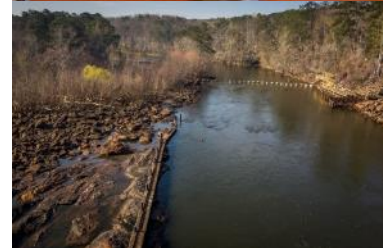
Lloyd Shoals Project Works Flow Release Sequence

Generating Capacity	18 MW
Number of units:	6 (horizontal, Francis-type)
Max. hydraulic capacity:	620 cfs/unit or 3,720 cfs total plant capacity
Full reservoir storage:	107,000 acre-feet
Normal operating range:	527 to 530 feet
Average annual inflow:	1,732 cfs
Operation mode:	Modified run-of-river
Minimum flow:	400 cfs or inflow, whichever is less
Spillway Capacity:	16,770 cfs

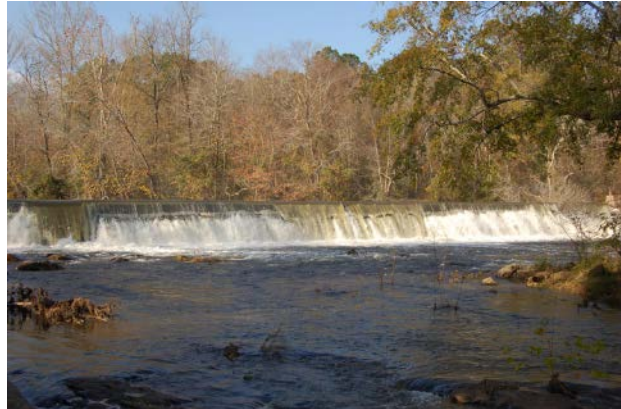
Medium Reservoirs – Modified Run-of-River Operation

- Some storage
- Water is stored for hours or days
- Inflow \neq outflow hourly
- Water is released for the week
Inflow = outflow on a weekly basis
- Example:
Lake Jackson (useable storage = 74,750 acre-feet)
- Project purpose: power generation

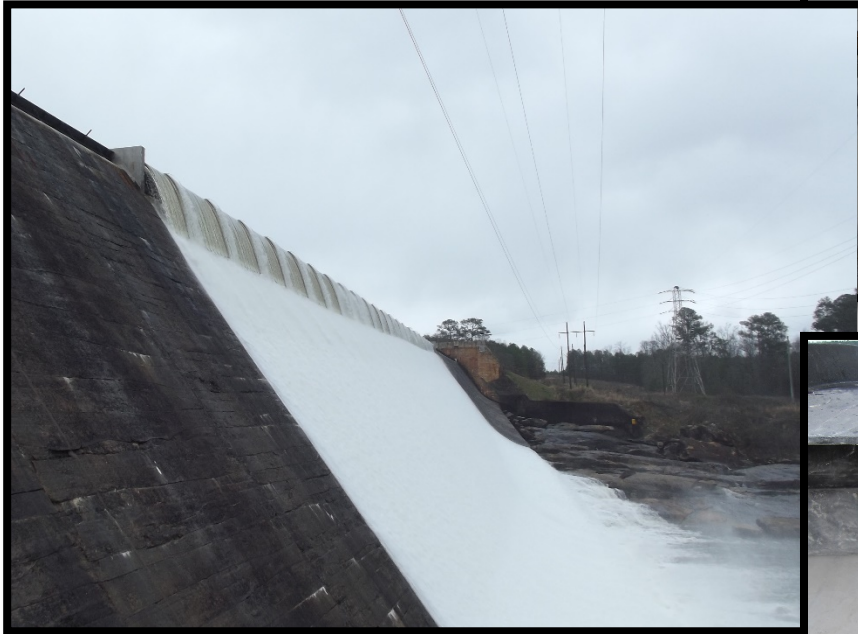
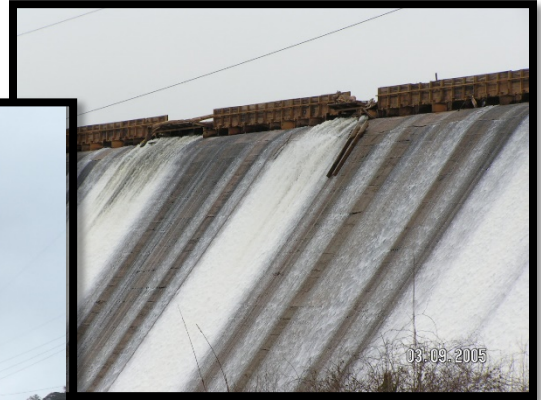
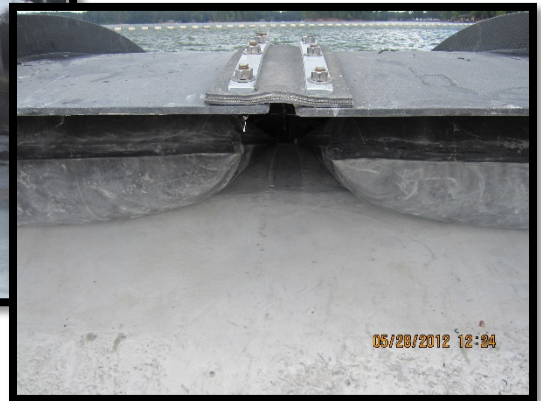
Spillway Gate Enhancement / Operational Improvements

Obermeyer Gates Significantly Reduce Frequency of Reservoir Fluctuations

- Installed in 2011/2012 to replace spillway flashboards
- Decrease frequency of Lake Jackson fluctuations outside of normal pool elevation range caused by high flow events
- Eliminate safety hazards for plant personnel
- Water saved provides more water for reliable, clean, and renewable generation

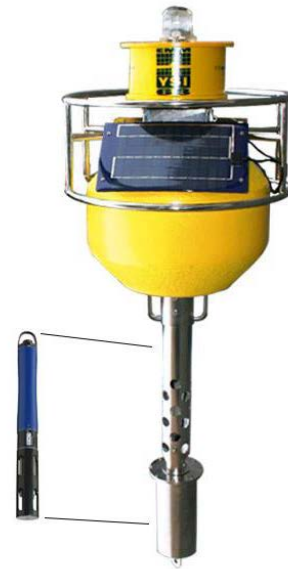
Methods – Tailrace Continuous Water Quality Monitoring

- Reconnaissance to choose monitoring station (LSTR)
- Buoy deployed July 2019
- Measurements at 1-m depth at hourly intervals:
 - Dissolved oxygen (DO), water temperature, pH, specific conductance, and turbidity
- *In-situ* measurements also taken at Tailrace Fishing Pier during 8 monthly buoy maintenance events (Jul-Nov, Jan-Mar)
- Monitoring continued through July 2020

- Passive draft tube aeration system installed for Units 2, 3, and 4 in 2006
- Improves and stabilizes summer DO levels in downstream releases
- Operated from May 15 through September, extending into October when low-flow conditions persist
- In 2019, draft tube aeration extended through mid-October

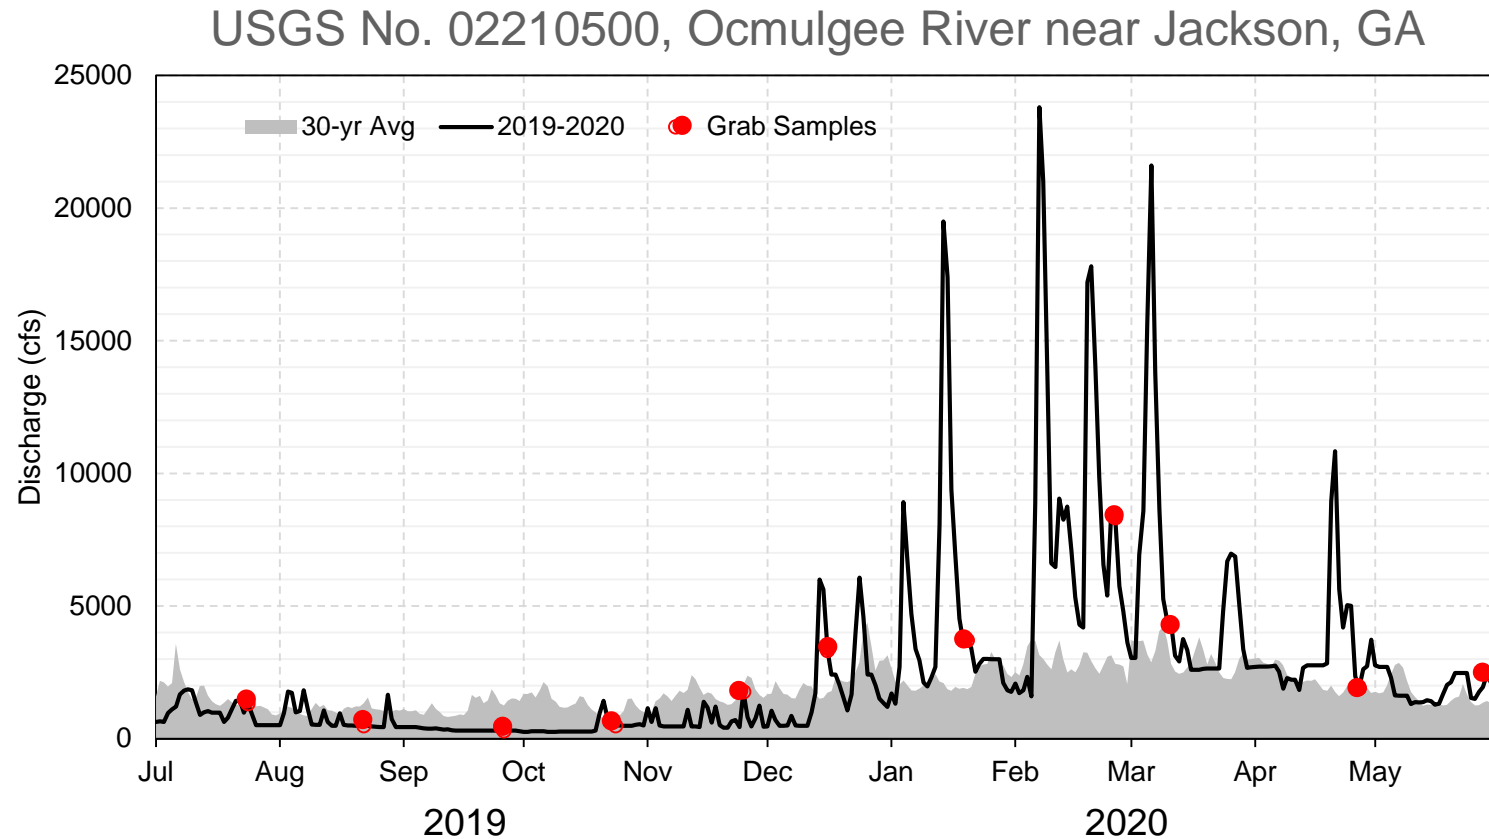
Ocmulgee River Daily Average Discharge during Study Period

- Prolonged low-flow conditions in fall 2019
- Multiple high-flow events in winter and spring 2020

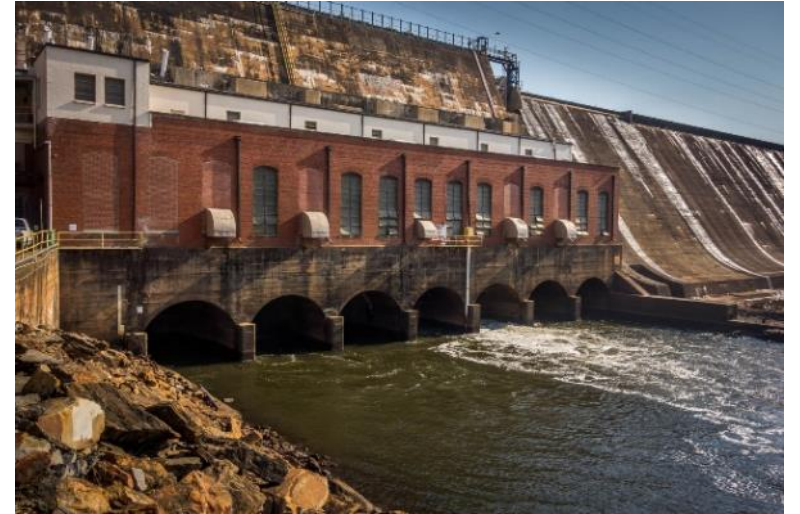
Turbine Characteristics of Lloyd Shoals Powerhouse

- Physical characteristics determine size of clearances, passageways, and rotational speeds, which can be sources of fish injury
 - Blade strikes, grinding, pressure changes, shear stress, and turbulence

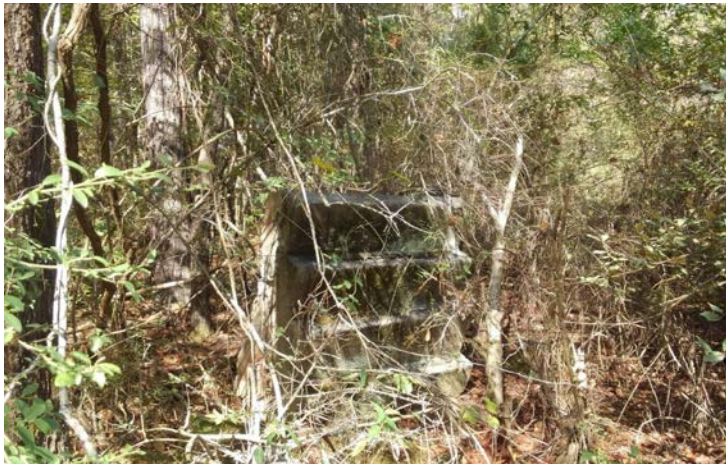
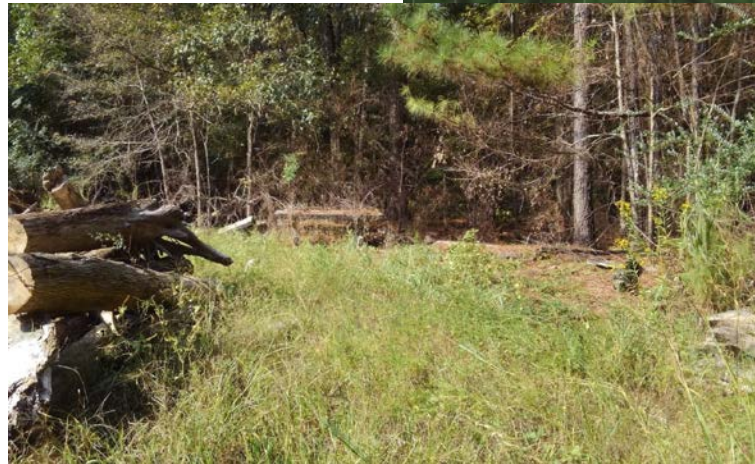
Results – Site 9BS17

- 1989: described as “extremely disturbed”, “possibly bulldozed,” and used as a dump
- Revisited in 2019
 - Little change in conditions from 1989
 - Recommended for continued monitoring

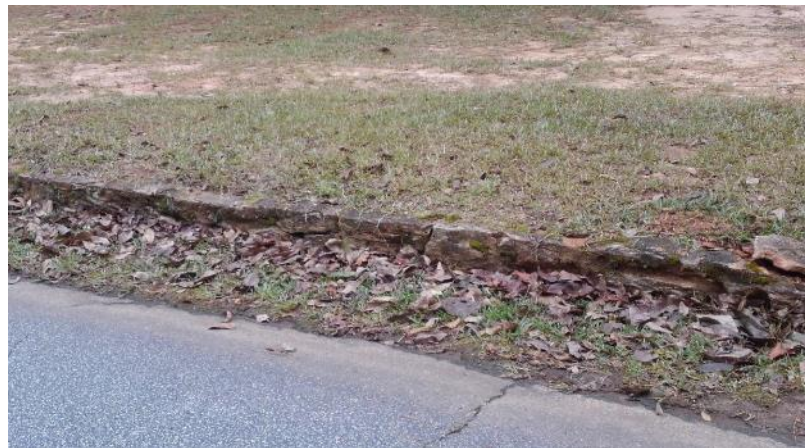
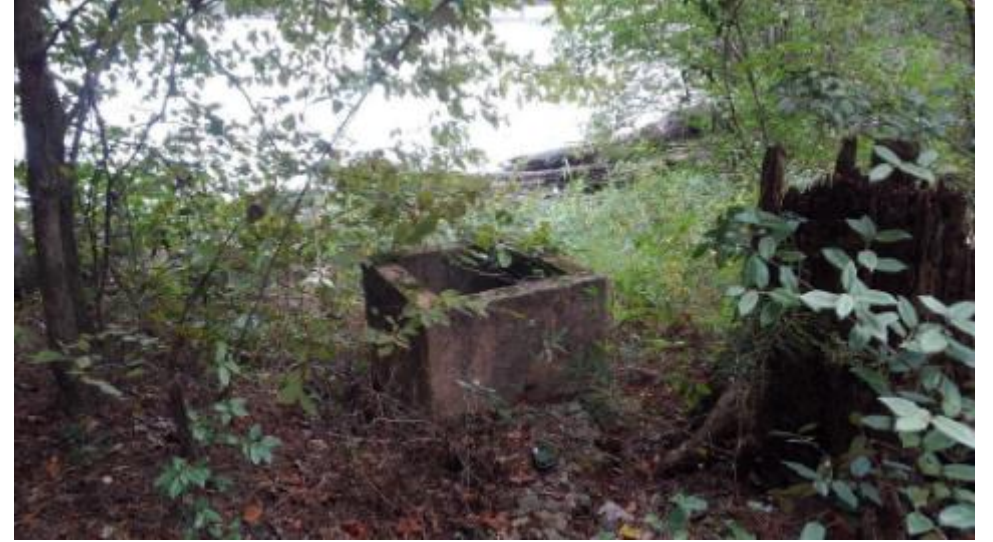
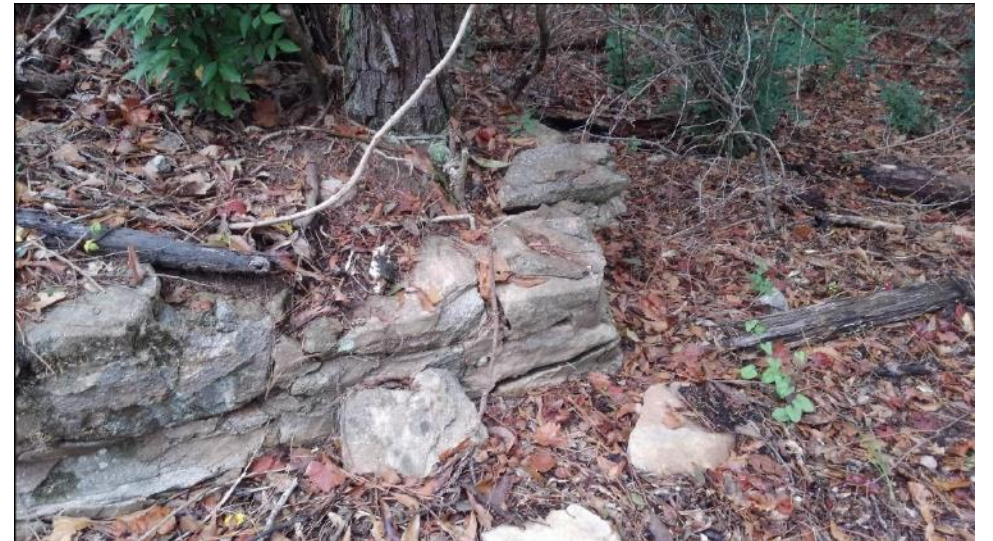
Results – Site 9BS18

- 1989: described as having “readily observed remains”: curbing, stone foundations, ornamental plants, concrete steps and slabs
- Revisited in 2019
 - No new impacts to structural remains
 - Variety of artifacts collected
 - Recommended for continued monitoring

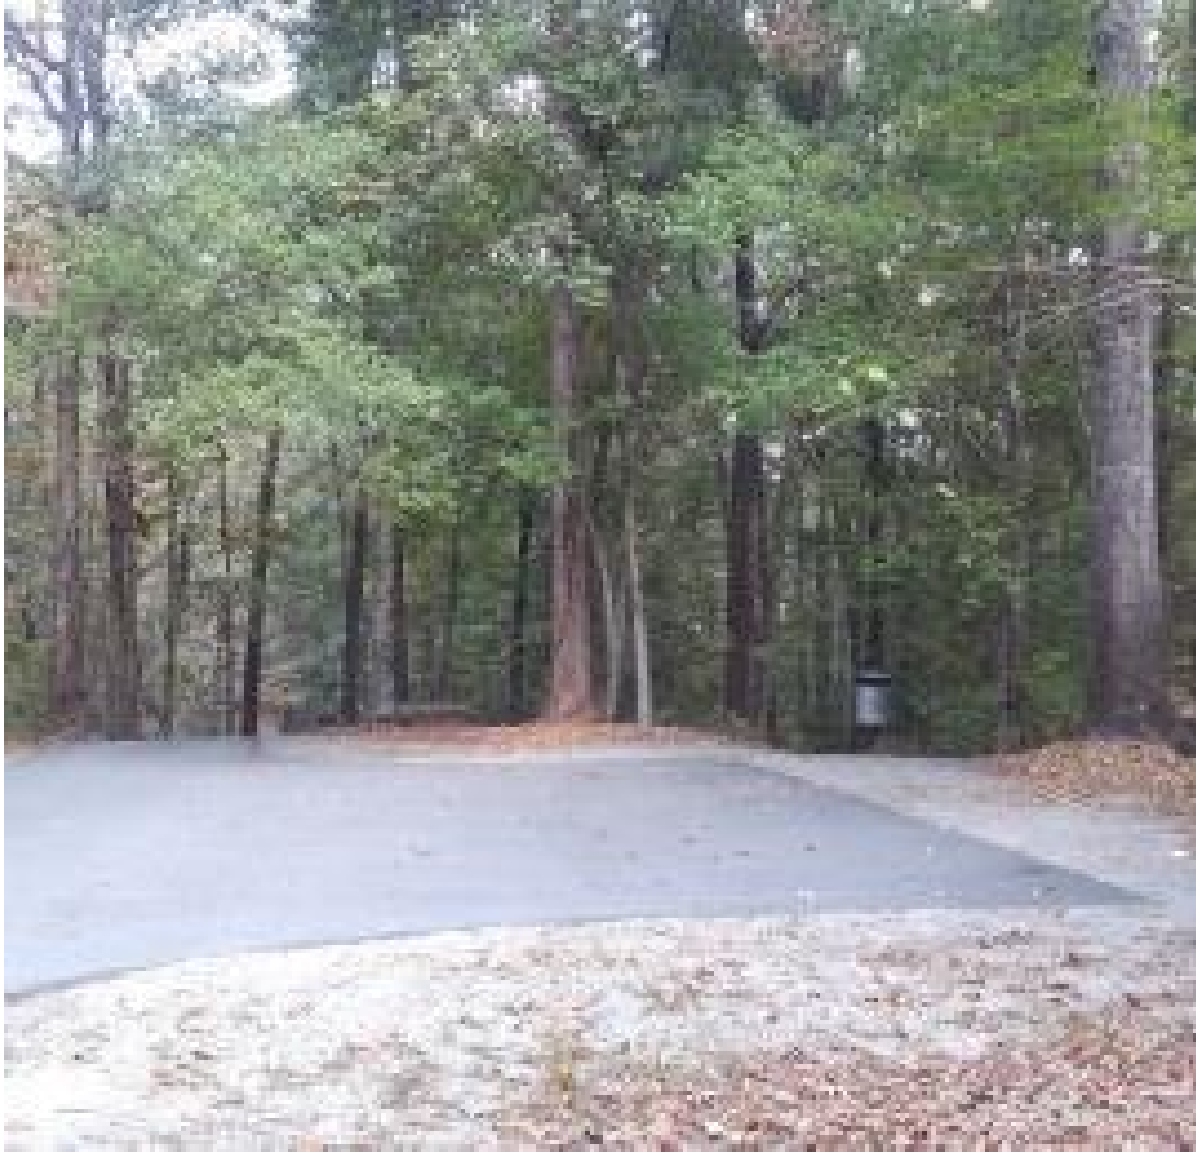
Results – Site 9BS19

- 1989: described as being on “artificially leveled terrace”
 - Thought to have been staging area during dam construction
 - Currently paved
- 2019 examination shows same conditions as 1989
 - No artifacts or structural remains
 - Not recommended for continued monitoring

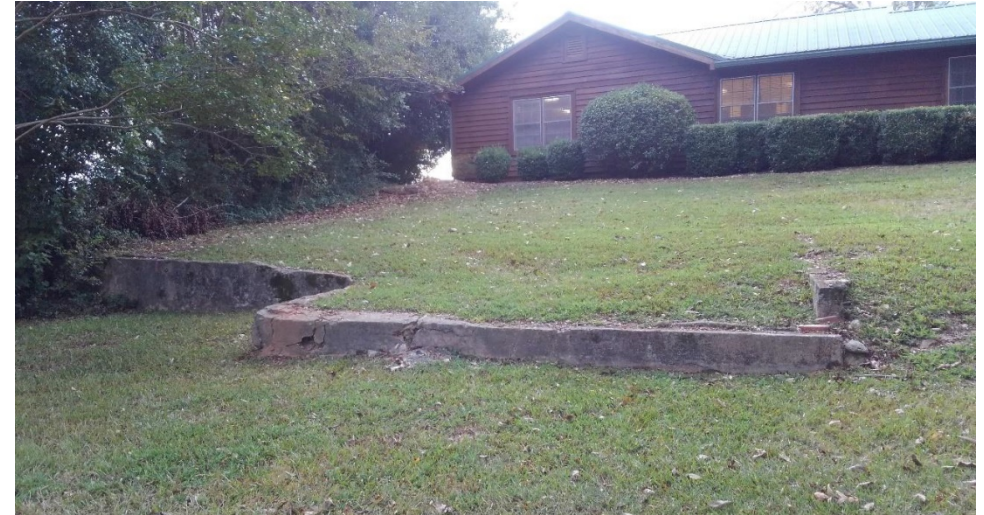
Results – Site 9BS20

- Location of plant supervisors' house, 1911-1967
- By 1989, site was office complex (field office, shop buildings, parking)
 - Foundations visible near field office
- 2019 assessment found little change to site conditions since 1989
 - Recommended for continued monitoring

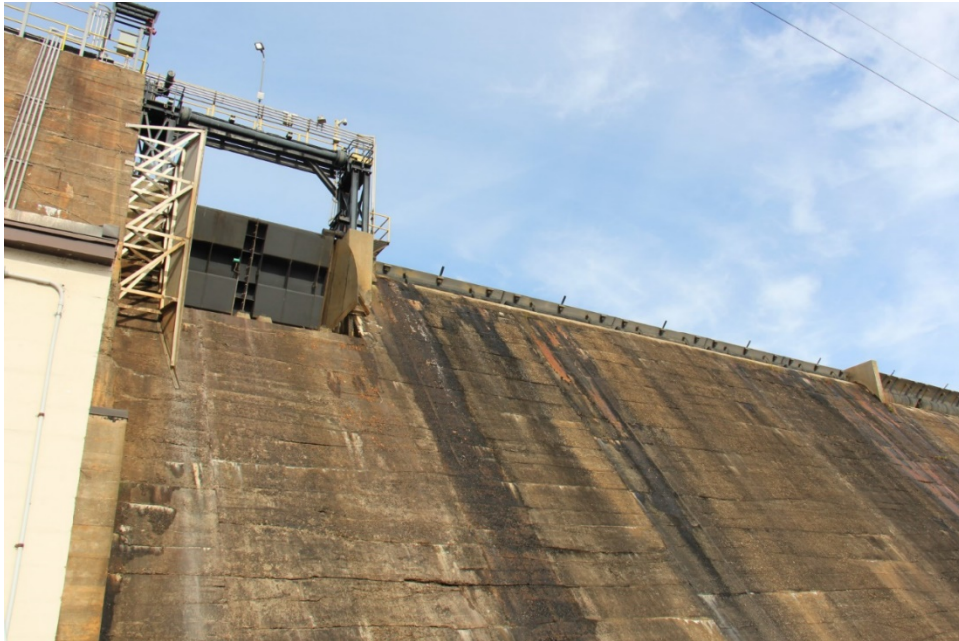
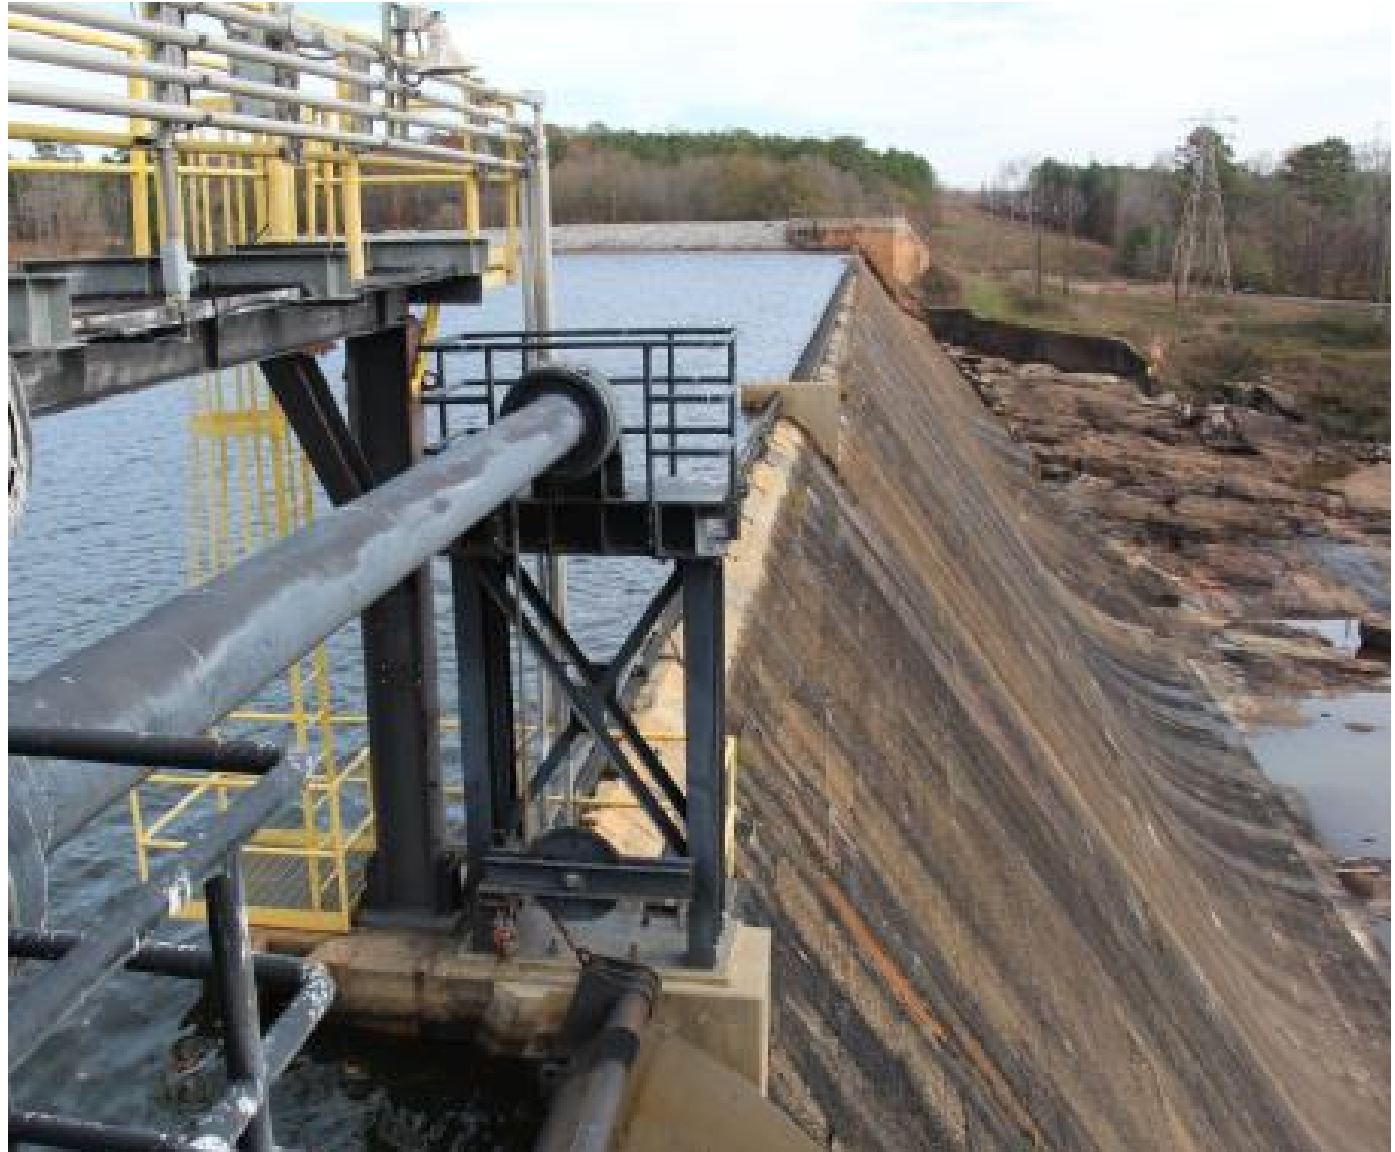
Results – Project Description

- Project Dam
 - Max height: 105 feet
 - Length: 1,599 feet

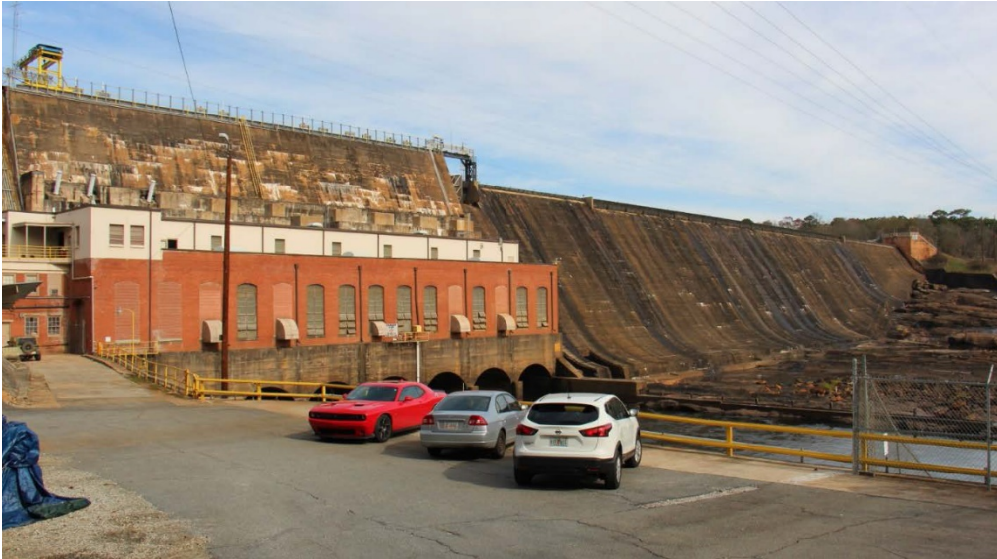
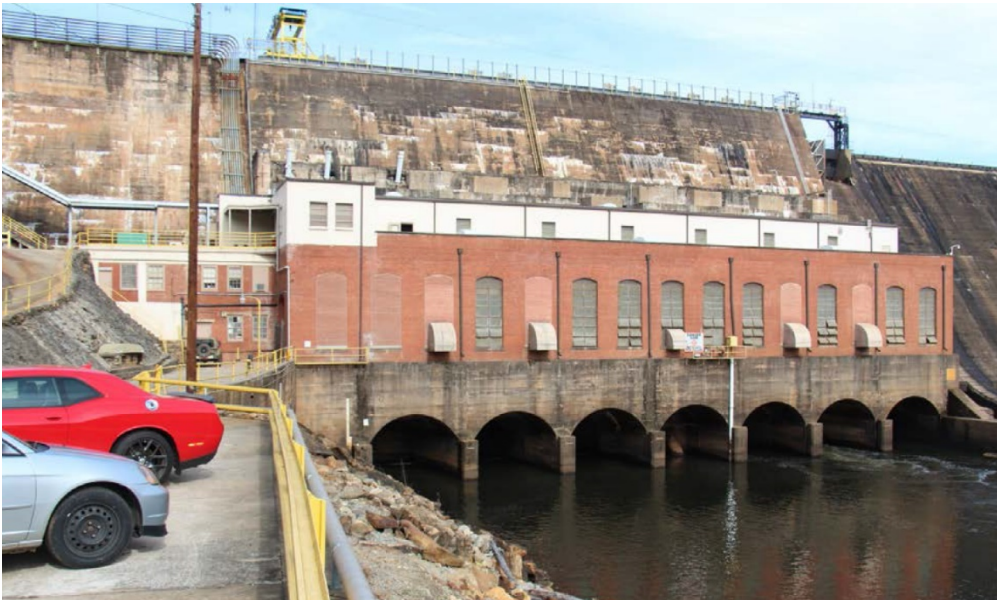
Results – Project Description

- Powerhouse
 - 1910 two-story building with brick curtain walls on a steel frame
 - Ground floor is original, second floor rebuilt after 1983 fire
 - Ground floor divided into 15 bays with windows, 6 have been modified/bricked over
 - On west end of powerhouse is original two-story brick wing that serves as administration and office area
 - Six original turbine-generator units
