LIMITED HYDROGEOLOGICAL ASSESSMENT REPORT FOR INACTIVE CCR LANDFILL

FORMER PLANT ARKWRIGHT – AP2-DAS LANDFILL
MACON-BIBB COUNTY, GEORGIA
FOR

Georgia Power

November 2018

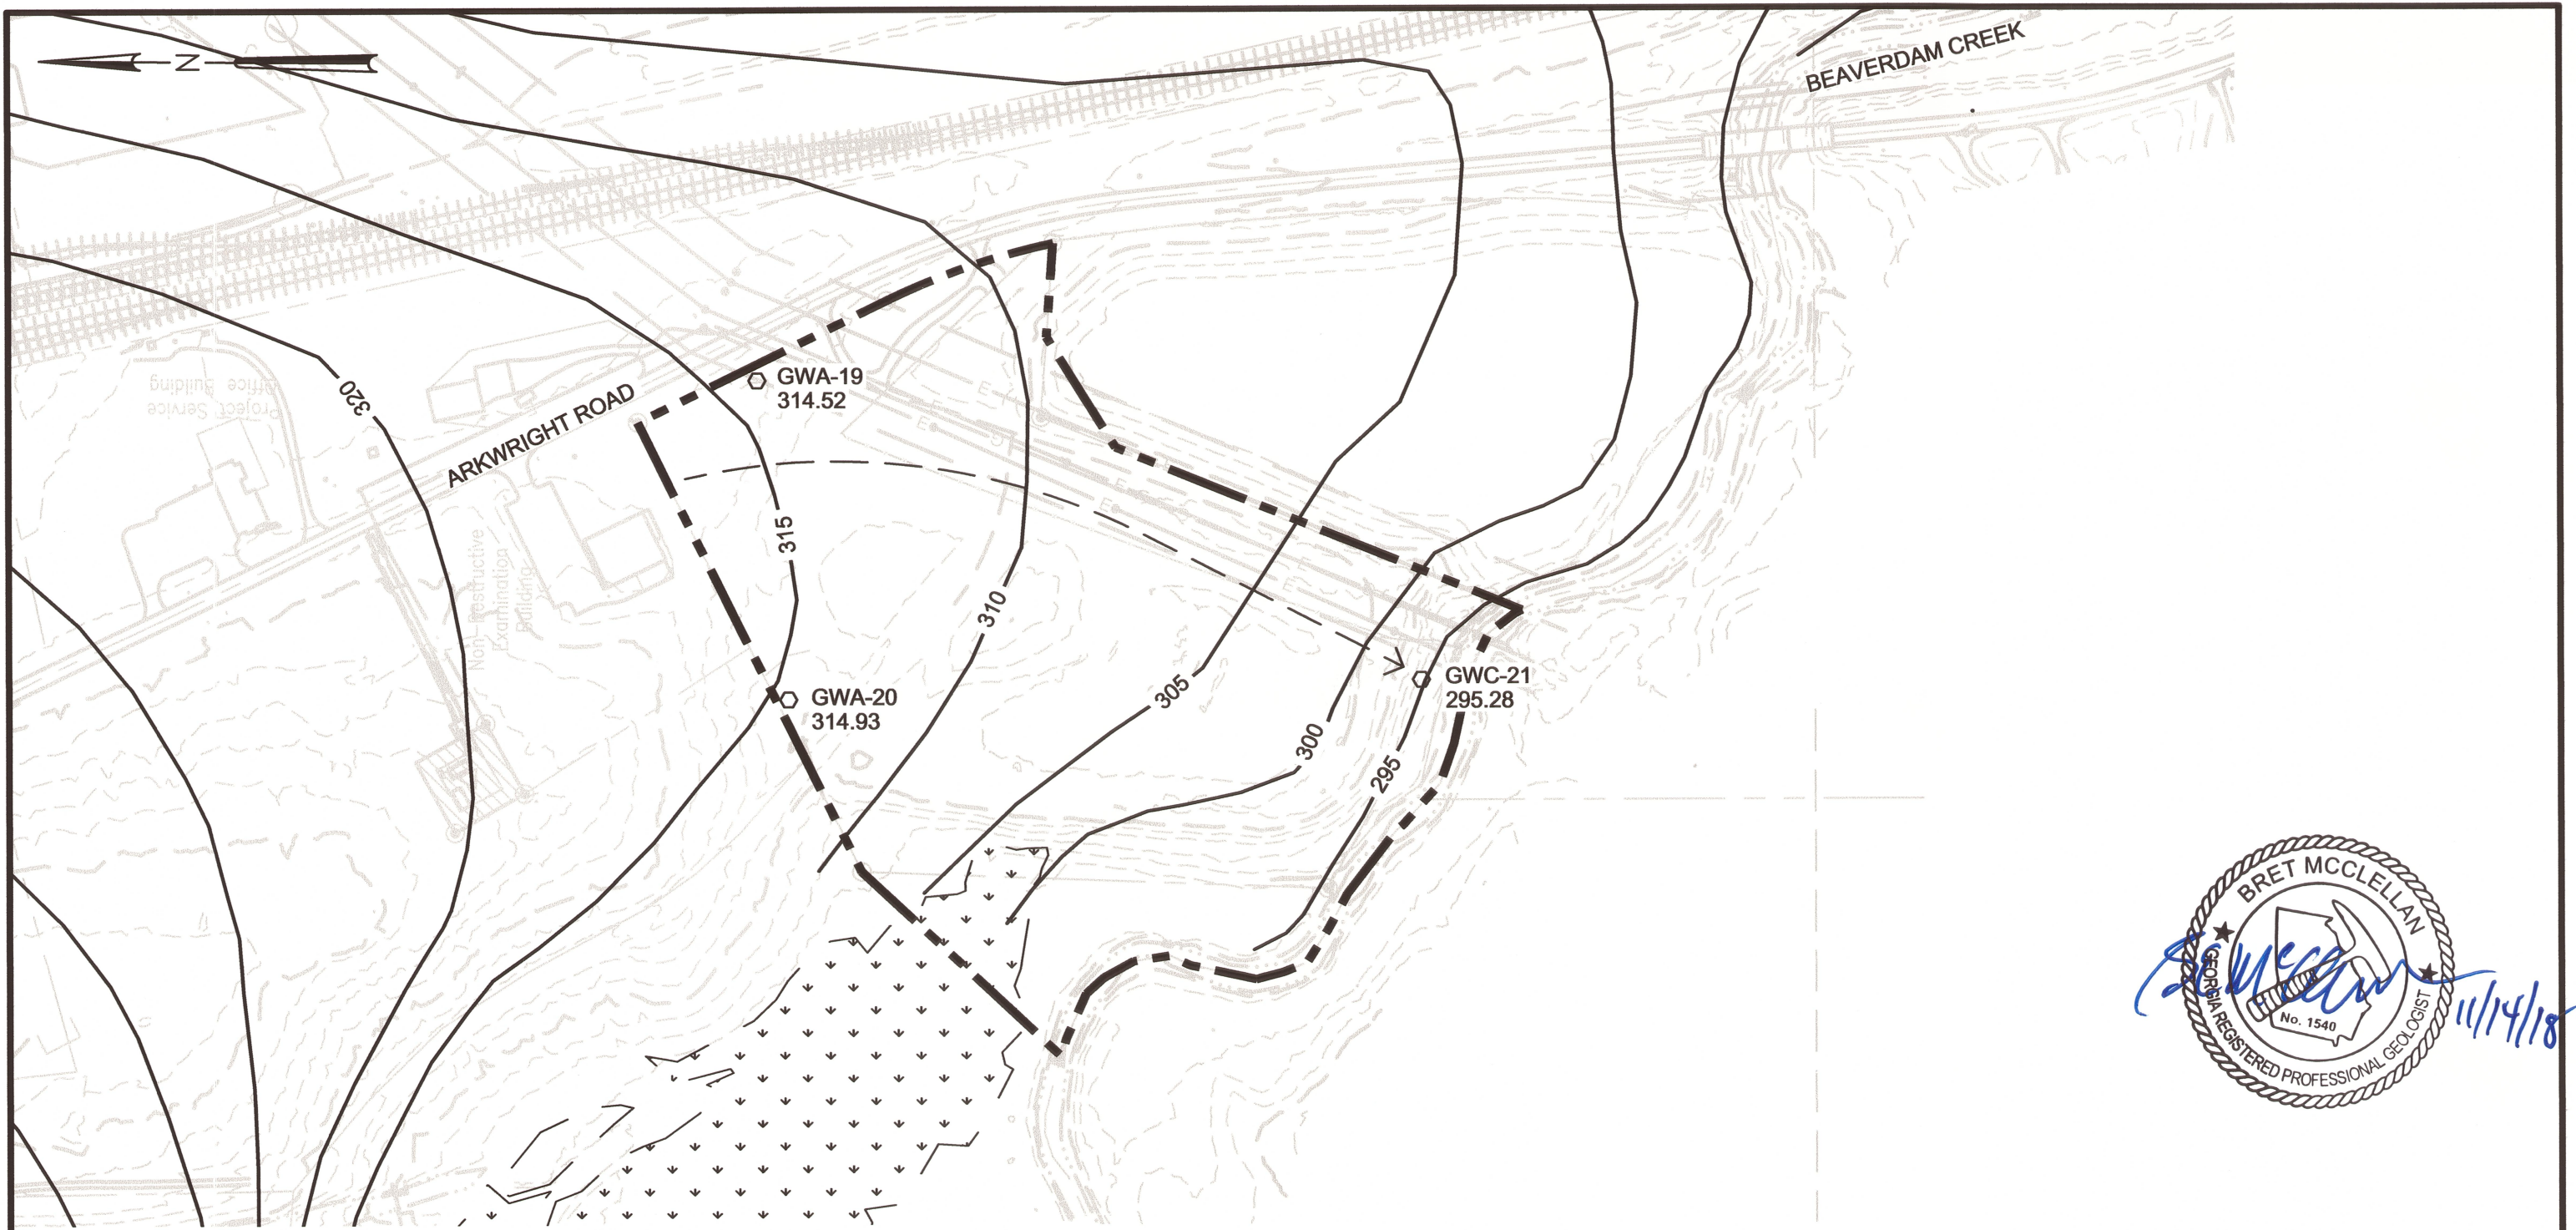
JACOBS	FORMER PLANT ARKWRIGHT AP2-DAS LANDFILL	PROJECT NO.: 35DK9203 DATE: NOVEMBER 2018 SCALE: AS SHOWN
	POTENTIOMETRIC SURFACE MAP	FIGURE NO.: 3

1. GROUNDWATER LEVELS COLLECTED BY ATLANTIC COAST CONSULTING, LLC. ON SEPTEMBER 11, 2018.
2. TOPOGRAPHIC SURVEY PROVIDED BY DONALDSON, GARRETT & ASSOCIATES, INC., JUNE 2018.

Groundwater at AP2-DAS Landfill flows generally southward toward. Figure 3 in Appendix A of this report provides a representation of the site's potentiometric surface. Data used for generation of the potentiometric contours is provided as Appendix B. Boring logs and well information is provided in the site's Groundwater Monitoring Plan, dated November 2018. CCR will be removed from AP2-DAS

Landfill, which may affect the site's potentiometric surface. However, it is not expected that removal of CCR will affect the general direction of groundwater flow.

Based on groundwater measurement data, the potentiometric surface ranges from approximately 35 feet below grade in the northern sections of the site to approximately 10.5 feet below grade in the southern section, closer to Beaverdam Creek.

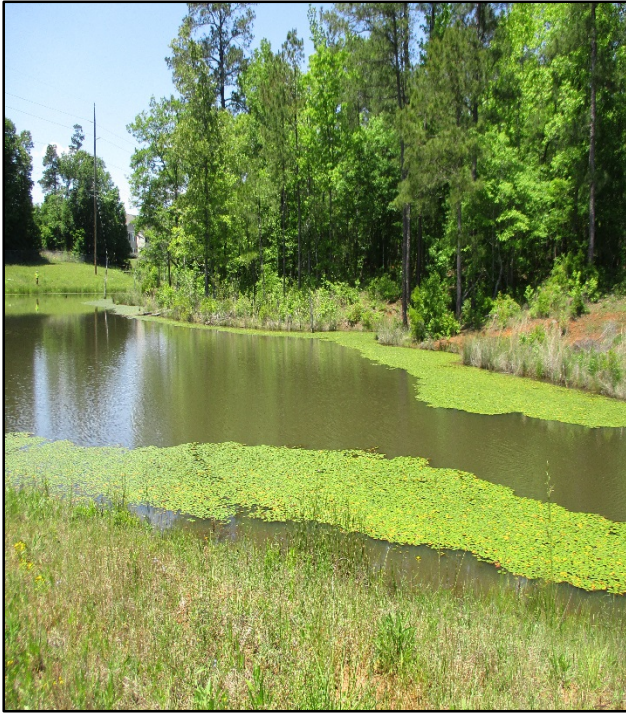
Photograph 1. Open Water 1

Open Water 1 (OW 1) – Open Water 1 is located upstream of Perennial Stream 4 at the northern end of the site. Open Water 1 is a man-made pond but has both an inlet and outlet stream, making it a buffered state water and a jurisdictional resource. The functional riparian buffer of the pond is greater than 50 feet wide along all banks and is dominated by maintained grass and loblolly pine. This system is considered

somewhat impaired due to buffer maintenance and sedimentation from disturbance upstream. At the time of survey, the water was cloudy but no foul odors were detected. Open Water 1 does not provide suitable habitat for any federal or state protected species.

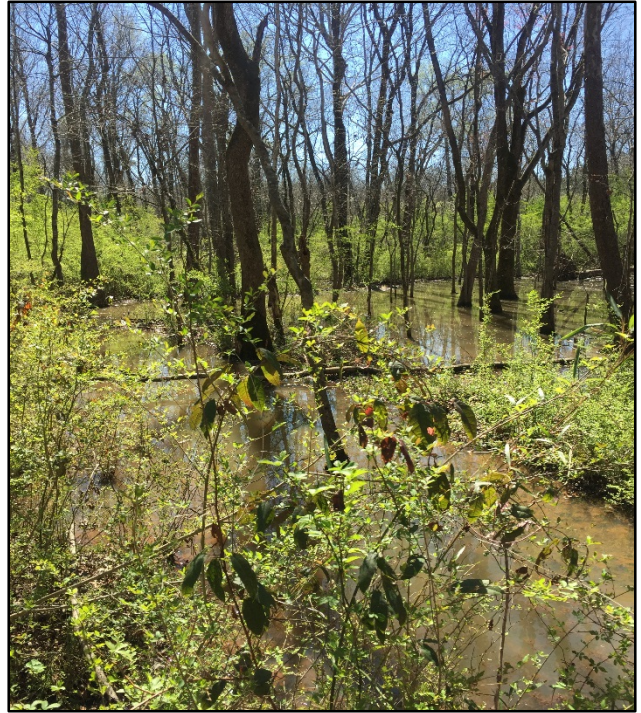
Photograph 2. Wetland 1

Wetland 1 (WL 1) – One palustrine forested wetland (PFO1B) was located in the central portion of the project survey area downstream of Perennial Stream 4 and upstream of Intermittent Stream 5 and Perennial Stream 2 (Beaver Dam Creek). This forested wetland is dominated by canopy and understory trees consisting of sweet gum (*Liquidambar styraciflua*), red maple (*Acer rubrum*), and Chinese privet (*Ligustrum sinense*). In wetter areas, the herbaceous layer is dominated by lizard tail (*Saururus cernuus*) and netted chain fern (*Woowardia areolata*). Hydric soils were identified throughout the area (depleted matrix).

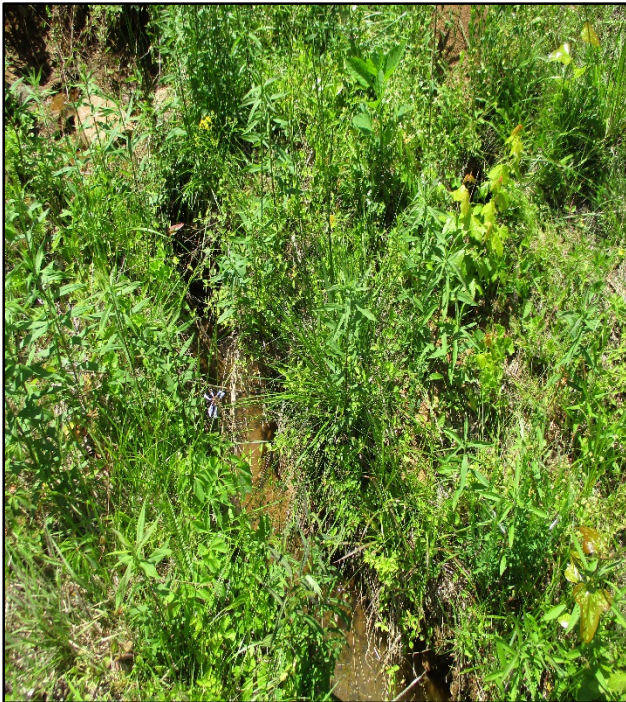
Photograph 3. Intermittent Stream 1

Intermittent Stream 1 (IS 1) – Intermittent Stream 1 is a warm water, intermittent stream with a streambed composed of sand (R4SB4). This system is located on the west side of OW 1. The intermittent characteristics observed within this system include the presence of baseflow and wretched vegetation. During the field survey, a NCDWQ data form was completed, which ranked this system as an intermittent stream. The functional riparian buffer of this system is greater than 50 feet wide along both banks and is dominated by maintained grass. This system is considered fully impaired due to buffer maintenance, bank erosion, sedimentation, and a rock ford which has been constructed in the upper part of the channel to allow maintenance vehicles to pass. At bankfull, the channel is approximately 3-4 feet wide and two feet deep with a wetted width of approximately 1-2 feet. At the time of the survey, the depth of the stream was approximately 0.5-1 foot, the water was cloudy, and no foul odors were detected. Intermittent Stream 1 is not listed on the most current 303(d) list. This stream is considered a buffered state water and would require a 25-foot protective buffer. Intermittent Stream 1 does not provide suitable habitat for any federal or state protected species and consideration of fish passage would not be required for this system.

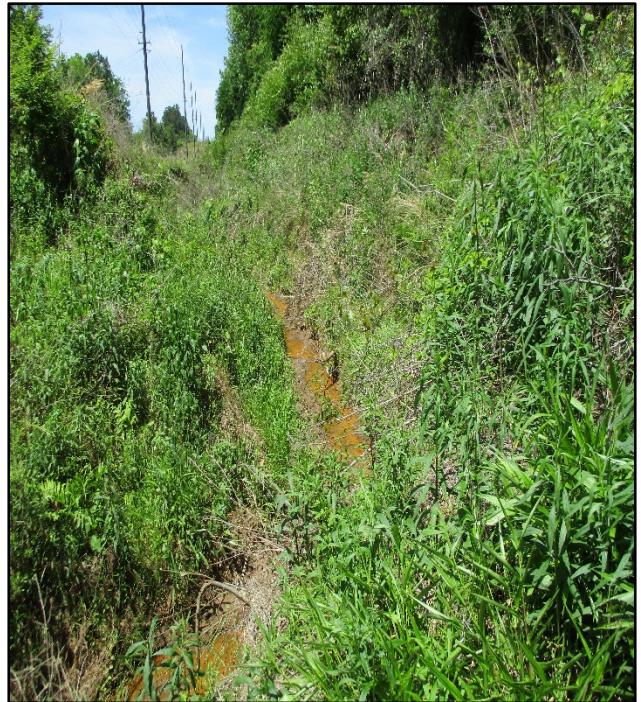
Photograph 4. Intermittent Stream 2

Intermittent Stream 2 (IS 2) - IS 2 is a warm water, intermittent stream with a streambed composed of sand (R4SB4). This system is located on the west side of the site near the existing Arkwright-Forest Road 115kV transmission line and flows south to Beaver Dam Creek (Perennial Stream 2). The intermittent characteristics observed within this system include the presence of baseflow and wretched vegetation. During the field survey, a NCDWQ data form was completed, which ranked this system as an intermittent stream. The functional riparian buffer of this system is greater than 50 feet wide along both banks and is composed of maintained utility right-of-way and mixed pine-hardwood species. This system is considered fully impaired due to buffer clearing and maintenance, severe erosion, and sedimentation from disturbance upstream. At bankfull, the channel is approximately 3-5 feet wide and 2-4 feet deep with a wetted width of approximately 2-3 feet. At the time of the survey, the depth of the stream was approximately 0.5-1 foot, the water was cloudy, and no foul odors were detected. Intermittent Stream 2 is not listed on the most current 303(d) list. This stream is considered a buffered state water and would require a 25-foot protective buffer. This stream does not provide suitable habitat for any federal or state protected species and consideration of fish passage would not be required for this system.

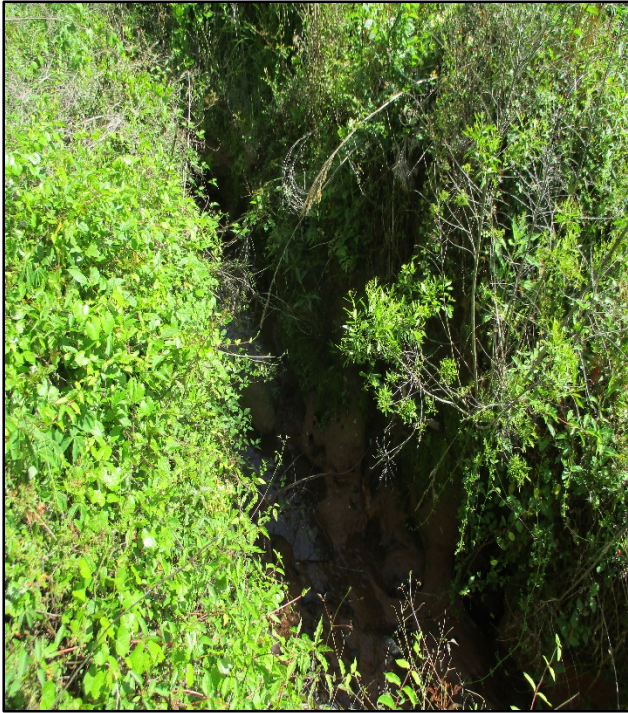
Photograph 5. Intermittent Stream 3

Intermittent Stream 3 (IS 3) – Intermittent Stream 3 is a warm water, intermittent stream with a streambed composed of sand (R4SB4). This system flows south, parallel to IS 2 within the ROW of an existing transmission line. The intermittent characteristics observed within this system include the presence of baseflow and wretched vegetation. During the field survey, a NCDWQ data form was completed, which ranked this system as an intermittent stream. The functional riparian buffer of this system is greater than 50 feet wide along both banks and is composed of maintained utility right-of-way. This system is considered somewhat impaired due to buffer clearing, severe bank erosion, and sedimentation from disturbance upstream. At bankfull, the channel is approximately two feet wide and one foot deep with a wetted width of

approximately one foot. At the time of the survey, the depth of the stream was approximately 0.5 foot, the water was cloudy, and no foul odors were detected. Intermittent Stream 3 is not listed on the most current 303(d) list. This stream is considered a buffered state water and would require a 25-foot protective buffer. Intermittent Stream 3 does not provide suitable habitat for any federal or state protected species and consideration of fish passage would not be required for this system.

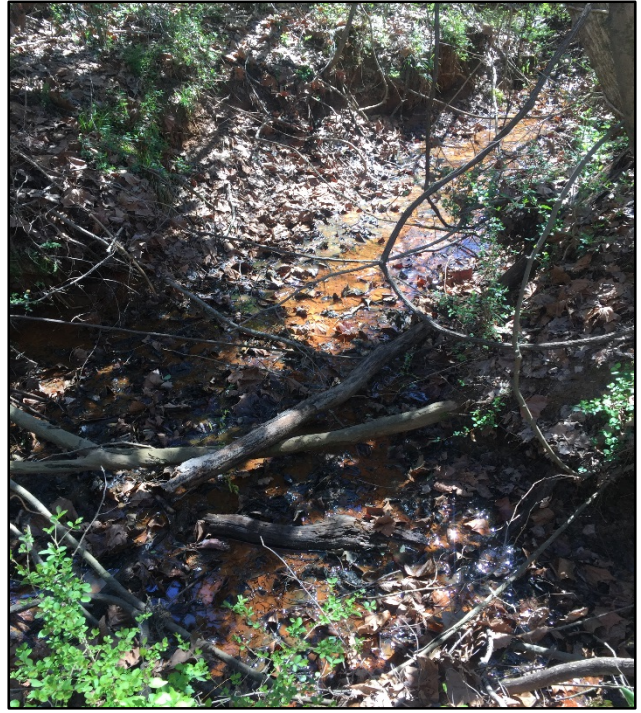
Photograph 6. Intermittent Stream 4

Intermittent Stream 4 (IS 4) – Intermittent Stream 4 is a warm water, intermittent stream with a streambed composed of sand and mud (R4SB45). This system is located adjacent to Wetland 1 and flows to IS 2. The intermittent characteristics observed within this system include the presence of baseflow and wretched vegetation. During the field survey, a NCDWQ data form was completed, which ranked this system as an intermittent stream. The functional riparian buffer of this system is greater than 50 feet wide along both banks and is composed of mixed pine hardwood species and some areas of maintained utility ROW. This system is considered somewhat impaired due to bank erosion and sedimentation. At bankfull, the channel is approximately 3-5 feet wide and 1-2 feet deep with a wetted width of approximately one foot. At the time of the survey, the depth of the stream was approximately 0.5 foot, the water was cloudy, and no foul odors were detected. Intermittent Stream 4 is not listed on the most current 303(d) list. This stream is considered a buffered state water and would require a 25-foot protective buffer. This stream does not provide suitable habitat for any federal or state protected species and consideration of fish passage would not be required for this system.

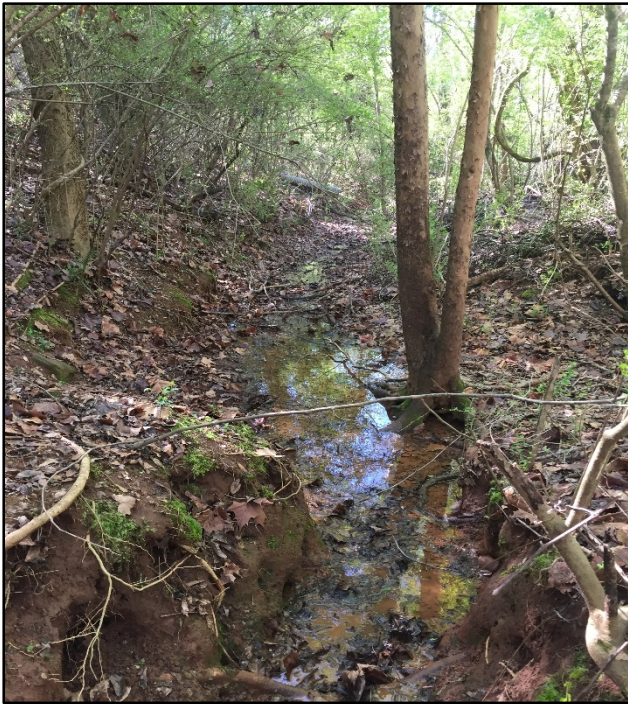
Photograph 7. Intermittent Stream 5

Intermittent Stream 5 (IS 5) – Intermittent Stream 5 is a warm water, intermittent stream with a streambed composed of sand and mud (R4SB45). This system is located to the south of Wetland 1 and flows to Beaver Dam Creek (Perennial Stream 2). The intermittent characteristics observed within this system include the presence of baseflow and wretched vegetation. During the field survey, a NCDWQ data form was completed, which ranked this system as an intermittent stream. The functional riparian buffer of this system is greater than 50 feet wide along both banks and is composed of mixed pine hardwood species. This system is considered somewhat impaired due to bank erosion and sedimentation. At bankfull, the channel is approximately 4-5 feet wide and 2-3 feet deep with a wetted width of approximately 1-2 feet. At the time of the survey, the depth of the stream was approximately 0.5 foot, the water was cloudy, and no foul odors were detected. Intermittent Stream 5 is not listed on the most current 303(d) list. This stream is considered a buffered state water and would require a 25-foot protective buffer. This stream does not provide suitable habitat for any federal or state protected species and consideration of fish passage would not be required for this system.

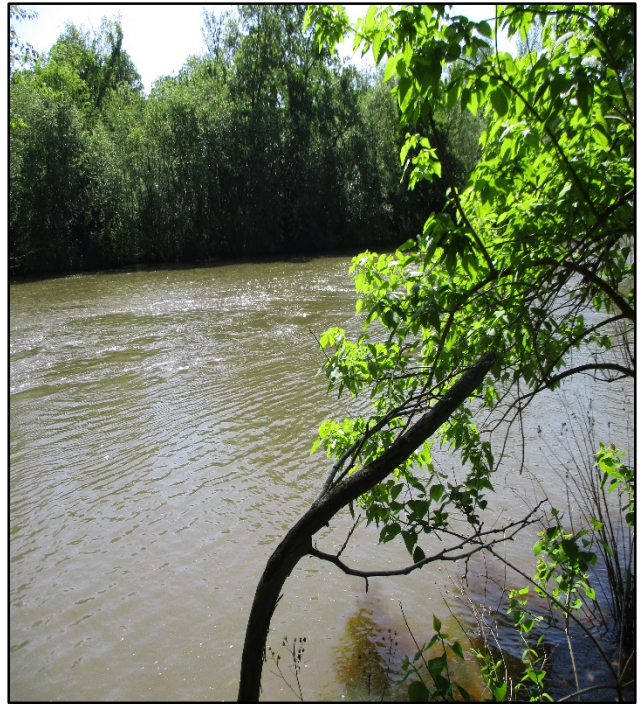
Photograph 8. Perennial Stream 1 (Ocmulgee River)

Perennial Stream 1 (PS 1) - Perennial Stream 1 is the Ocmulgee River, a warm water stream with a substrate composed of sand, silt, and cobble-gravel (R2UB12). The perennial characteristics observed within this system include the presence of baseflow and wretched vegetation. During the field survey, a NCDWQ data form was completed, which ranked this system as a perennial stream. The functional riparian buffer of this system is greater than 50 feet wide along both banks, and is composed of mixed pine hardwood species. This system is considered somewhat impaired due to bank erosion, sedimentation, and pollution. At bankfull, the channel is approximately 150-200 feet wide and 15 feet deep with a wetted width of approximately 140-185 feet. Within the survey area, Perennial Stream 1 is not listed on the most current 303(d) list, but it does become listed approximately 10 miles downstream. This stream is a state water and would require a 25-foot protective buffer. Perennial Stream 1 provides suitable habitat for one state protected species, the robust redhorse. Consideration of fish passage would be required for any proposed impacts to this system.

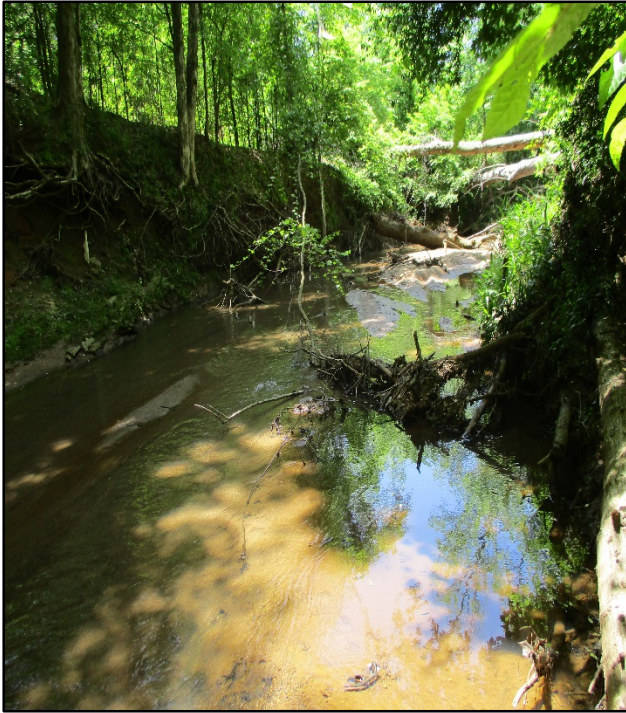
Photograph 9. Perennial Stream 2 (Beaver Dam Creek)

Perennial Stream 2 (PS 2) - Perennial Stream 2 is Beaver Dam Creek, a tributary to PS 1 (Ocmulgee River). Perennial Stream 2 is a warm water stream with a substrate composed of sand and silt (R2UB2). The perennial characteristics observed within this system include the presence of baseflow and wretched vegetation. During the field survey, a NCDWQ data form was completed which ranked this system as a perennial stream. The functional riparian buffer of this system is greater than 50 feet wide along both banks, and is composed of mixed pine hardwood species. This system is considered somewhat impaired due to bank erosion, sedimentation, and roadway pollutants. At bankfull, the channel is approximately 45-50 feet wide and 4-8 feet deep with a wetted width of approximately 30-40 feet. At the time of the survey, the depth of the stream was approximately 1-3 feet, the water was cloudy, and no foul odors were detected. Perennial Stream 2 is not listed on the most current 303(d) list. This stream is a state water and would require a 25-foot protective buffer. This stream does not provide suitable habitat for any federal protected species but does provide habitat for the state protected Altamaha shiner. Consideration of fish passage would be required for any proposed impacts to this system.

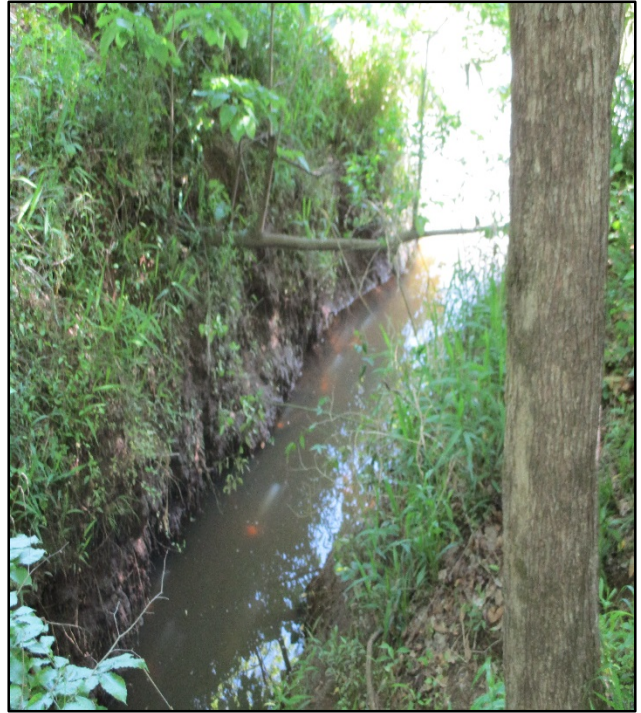
Photograph 10. Perennial Stream 3

Perennial Stream 3 (PS 3) - Perennial Stream 3 occurs on the northeast side of the site and is a tributary to PS 1 (Ocmulgee River). Perennial Stream 3 is a warm water stream composed of sand and silt (R2UB2). The perennial characteristics observed within this system include the presence of baseflow and wretched vegetation. During the field survey, a NCDWQ data form was completed, which ranked this system as a perennial stream. The functional riparian buffer of this system is greater than 50 feet wide along both banks, and is composed of grass and mixed pine hardwood species. This system is considered somewhat impaired due to heavy amounts of debris, bank erosion, and sedimentation. At bankfull, the channel is approximately 10-15 feet wide and 3-4 feet deep with a wetted width of approximately 8-10 feet. At the time of the survey, the depth of the stream was approximately one foot, the water was cloudy, and no foul odors were detected. Perennial Stream 3 is not listed on the most current 303(d) list. This stream is a state water and would require a 25-foot protective buffer. This stream does not provide suitable habitat for any federal or state protected species but consideration of fish passage would be required for any proposed impacts to this system.

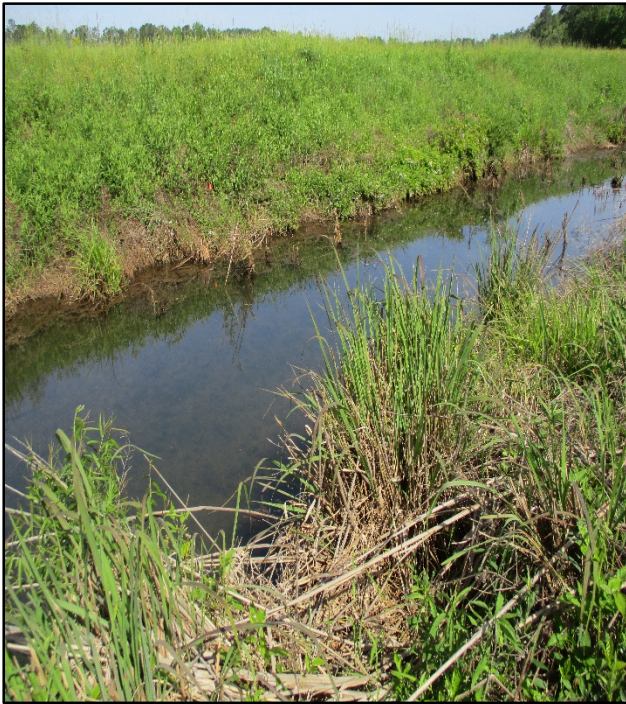
Photograph 11. Perennial Stream 4

Perennial Stream 4 (PS 4) - Perennial Stream 4 originates at the base of OW 6, at the north end of the site. Perennial Stream 4 is a warm water stream with a substrate composed of sand and mud (R2UB23). The perennial characteristics observed within this system include the presence of baseflow and wretched vegetation. During the field survey, a NCDWQ data form was completed, which ranked this system as a perennial stream. The functional riparian buffer of this system is greater than 50 feet wide along both banks, and is primarily composed of maintained grasses. This system is considered fully impaired due to impoundment, channelization, and culverting. At bankfull, the channel is approximately 5-6 feet wide and 1-2 feet deep with a wetted width of approximately 3 feet. At the time of the survey, the depth of the stream was approximately four to six inches, the water was clear, and no foul odors were detected. Perennial Stream 4 is not listed on the most current 303(d) list. This stream is a state water and would require a 25-foot protective buffer. This stream does not provide suitable habitat for any federal or state protected species but consideration of fish passage would be required for any proposed impacts to this system.
