# **2020 Semi-Annual Groundwater Monitoring and Corrective Action Report**

Georgia Power Company – Plant Mitchell  
Ash Ponds A, 1, and 2  
Project No.: 6122160170

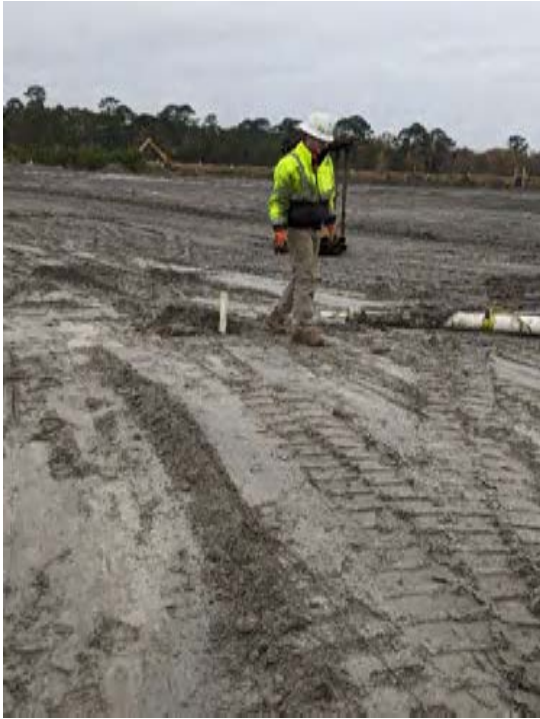
Wood Photographic Log	PZ-03R
Site: Plant Mitchell, Albany, Georgia	3
Photographer: Daniel Howard	Date: 12/17/20

Casing above ground surface has been removed.

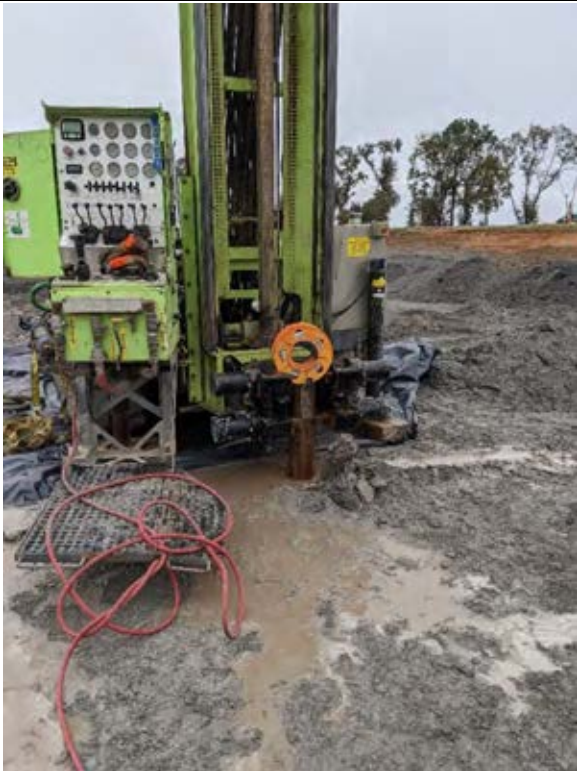
Wood Photographic Log	PZ-03R
Site: Plant Mitchell, Albany, Georgia	4
Photographer: Daniel Howard	Date: 12/17/20

<p>Two-inch inner casing of well overdrilled with 6 inch auger down to 53 ft.</p>

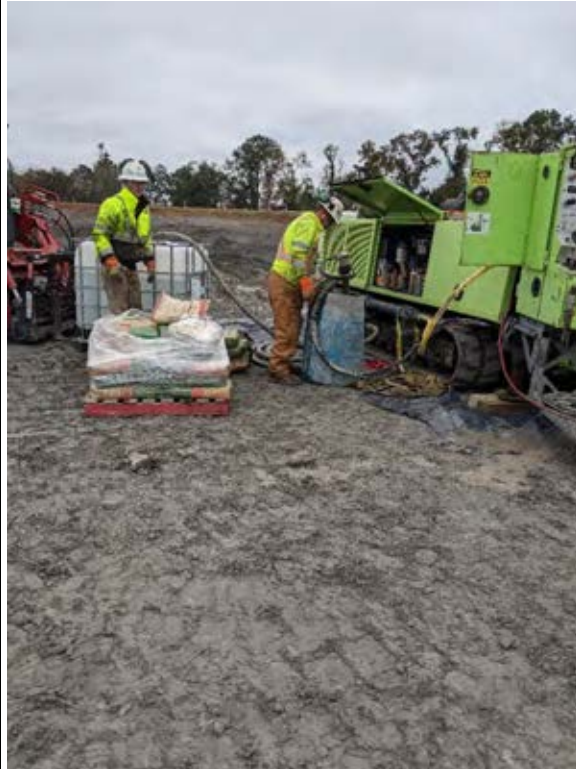
Wood Photographic Log	PZ-03R
Site: Plant Mitchell, Albany, Georgia	5
Photographer: Daniel Howard	Date: 12/17/20

Mixing grout to backfill borehole to bottom of ash pond. Approximately 26.5 gallons

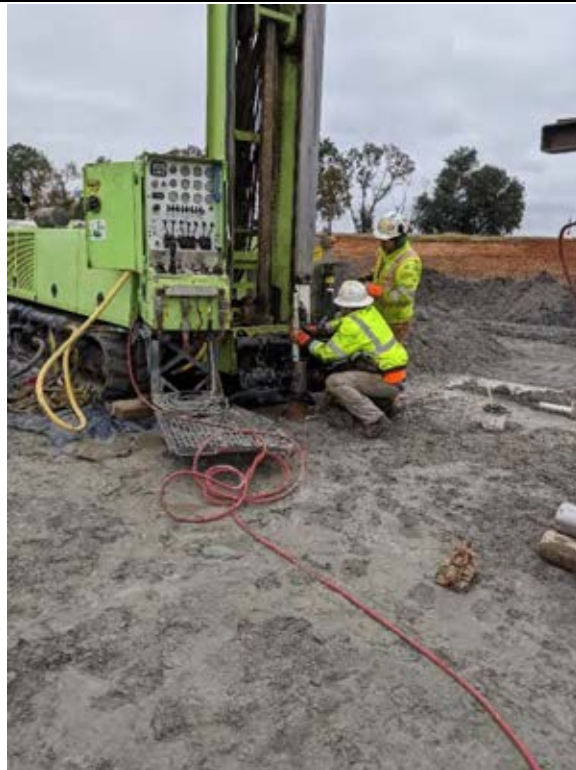
Wood Photographic Log	PZ-03R
Site: Plant Mitchell, Albany, Georgia	6
Photographer: Daniel Howard	Date: 12/17/20

Removing augers and well casing after backfilling with grout.

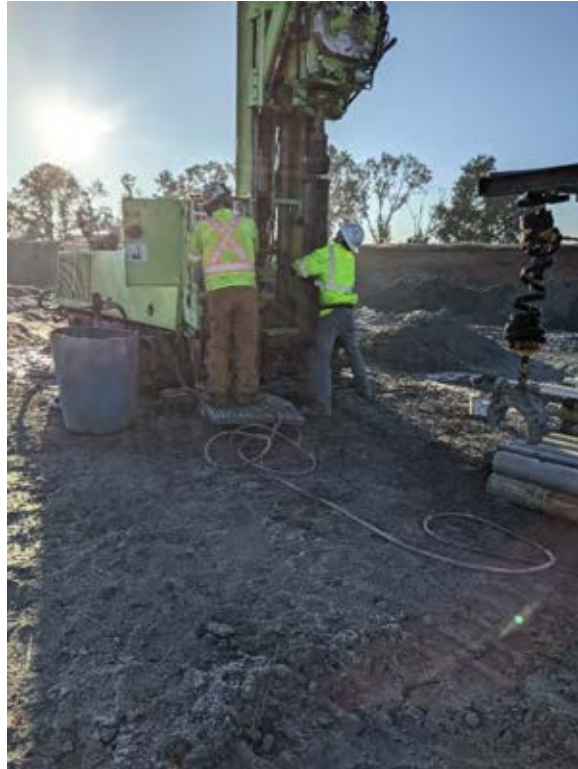
Wood Photographic Log	PZ-03R
Site: Plant Mitchell, Albany, Georgia	9
Photographer: Daniel Howard	Date: 12/18/20

Overdrilling outer casing with 9-inch augers in upper 25 ft of the well down to bottom of ash pond.

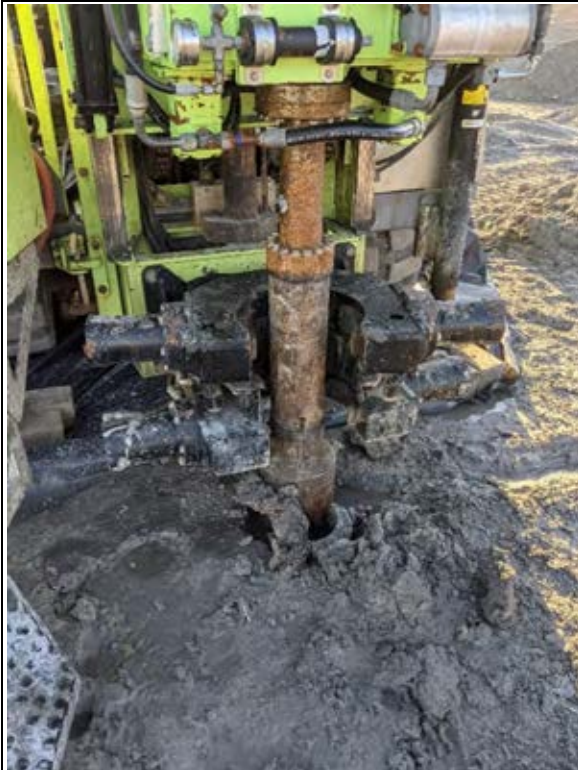
Wood Photographic Log	PZ-03R
Site: Plant Mitchell, Albany, Georgia	10
Photographer: Daniel Howard	Date: 12/18/20

Drilled down to 25 ft. to bottom of ash pond.

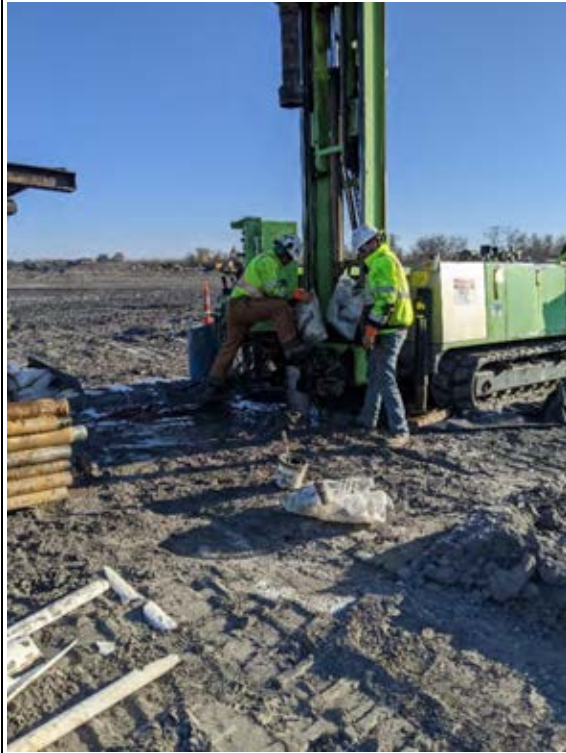
Wood Photographic Log	PZ-03R
Plant Mitchell, Albany, Georgia	11
Photographer: Daniel Howard	Date: 12/18/20

Backfilling 25 ft., 9-inch borehole through ash with sand.

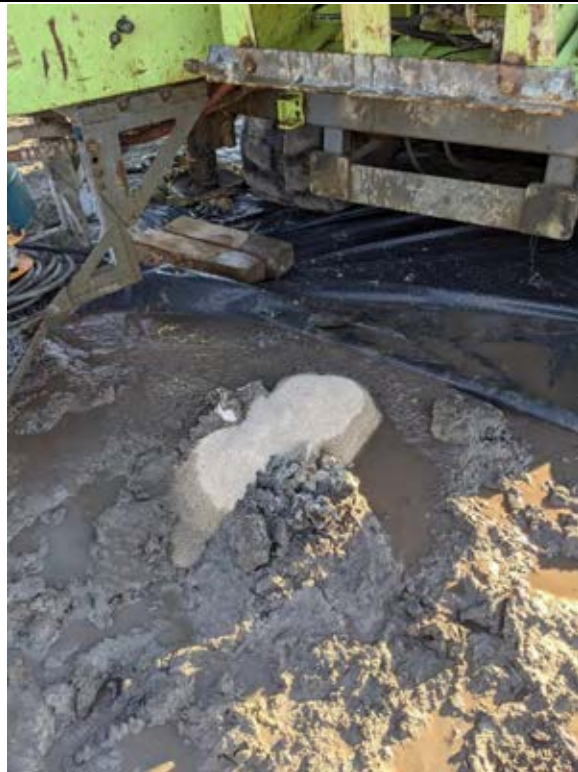
Wood Photographic Log	PZ-03R
Site: Plant Mitchell, Albany, Georgia	12
Photographer: Daniel Howard	Date: 12/18/20

Finished backfilling 25 ft, 9-inch borehole from bottom of ash pond to ground surface.
